HP 83621A/31A/51A Synthesized Sweepers Troubleshooting Manual

HP Part No. 08360-90048
Printed in USA April 1993

Edition 4

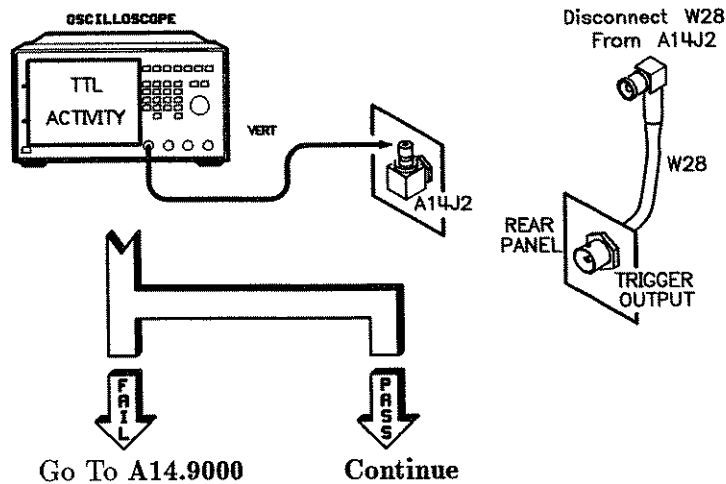
ILT.3601 Press **PRESET**. Check for a negative going TTL pulse at A14J2.

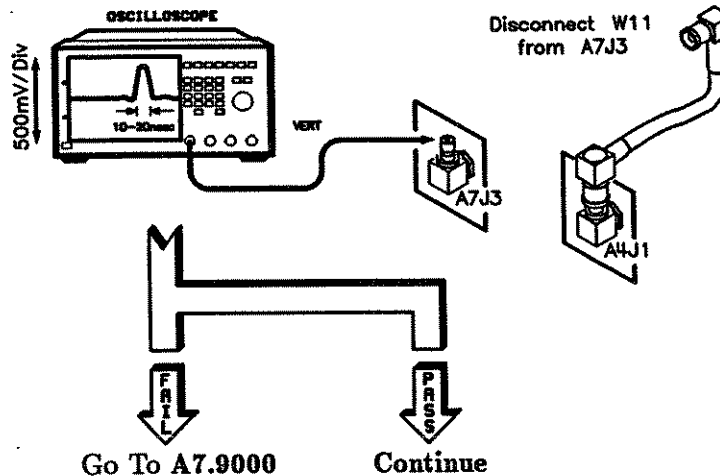
A4.320 The pulse width is 10 to 20 ns. The frequency is 125 kHz. The oscilloscope must present a 50Ω load. Do not use a high impedance probe. The combination of low frequency and narrow pulse width makes this a very difficult pulse to see. Do not use a frequency counter to check frequency, because of the tendency to count the second harmonic.

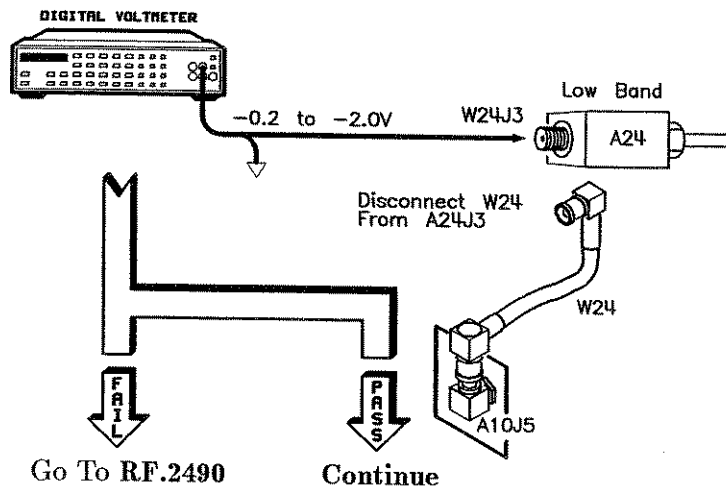
RF.803 Measure the DC voltage at 100 MHz, 500 MHz, 1 GHz, and 1.9 GHz.

RF.804 Replace W24 and to to the Troubleshooting Foldout, block 1 (located just prior to the "Special Cases" tab).
